**A Dendrochronological Study of
The T. Thomas Fortune House
Red Bank, Monmouth County, NJ**

October 31, 2017

Introduction

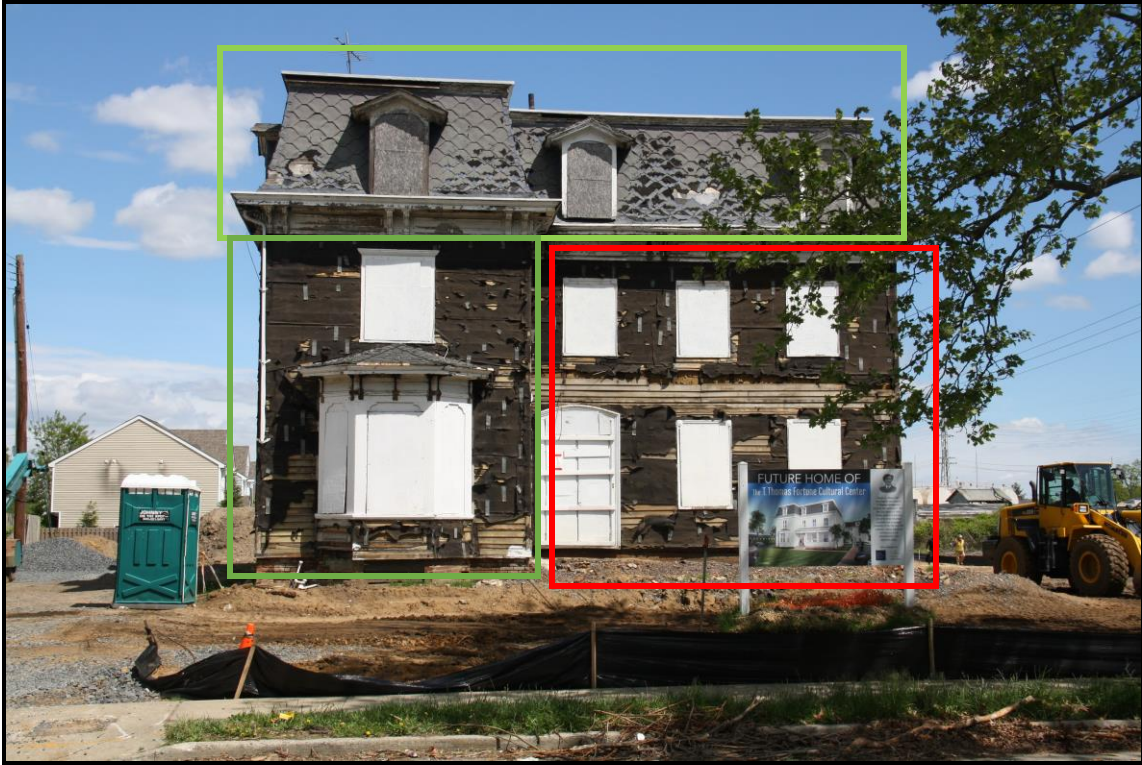
View looking north towards the T. Thomas Fortune house, the earliest build episode of the house is outlined in red. Green blocks indicate Victorian additions.

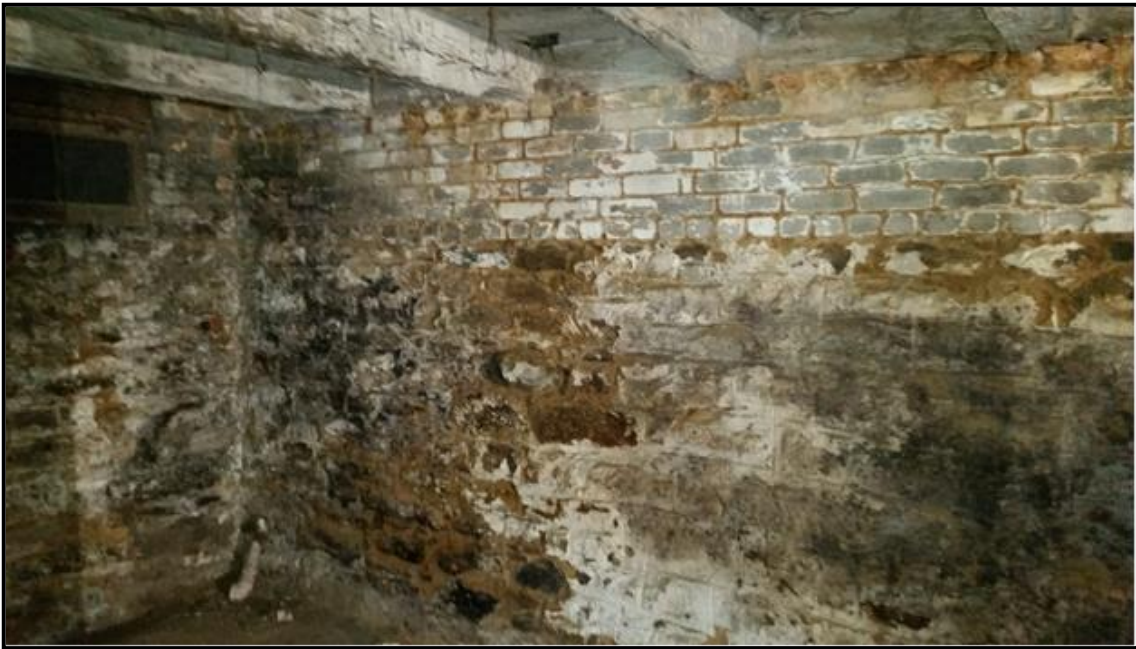
View looking southeast in the basement of the main block of the house showing the original rough stone foundation, overlain by the brick foundation and the timber joists supporting the first floor.

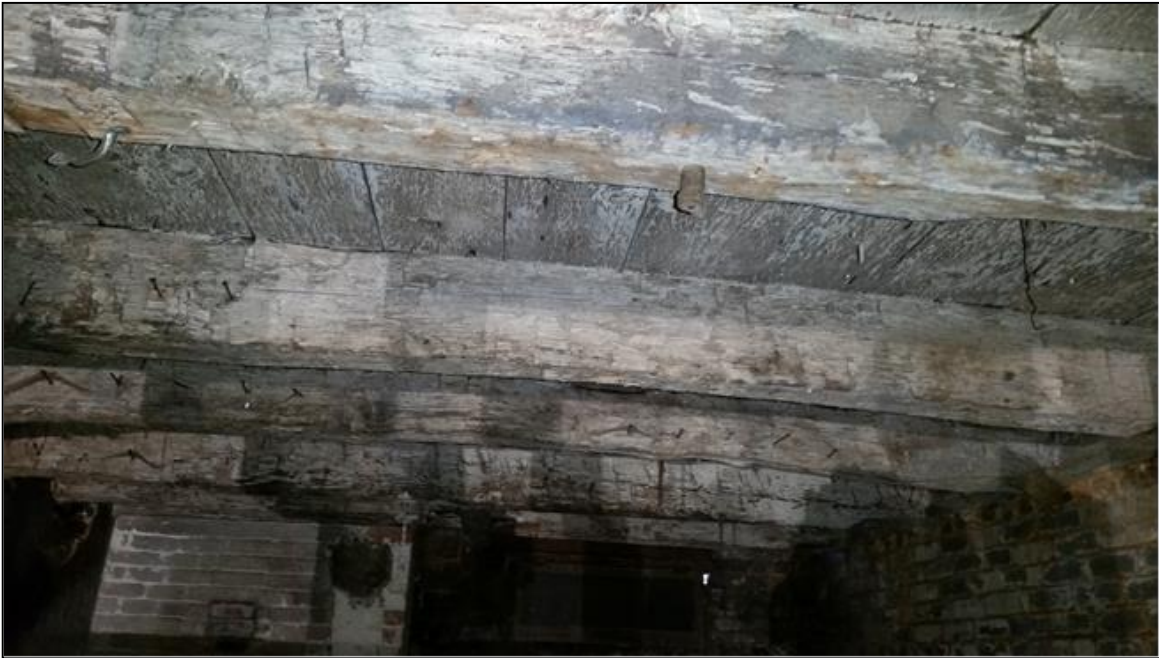
View looking east in the cellar of the main block of the house showing the joists supporting the first floor and a brick fireplace/chimney support.

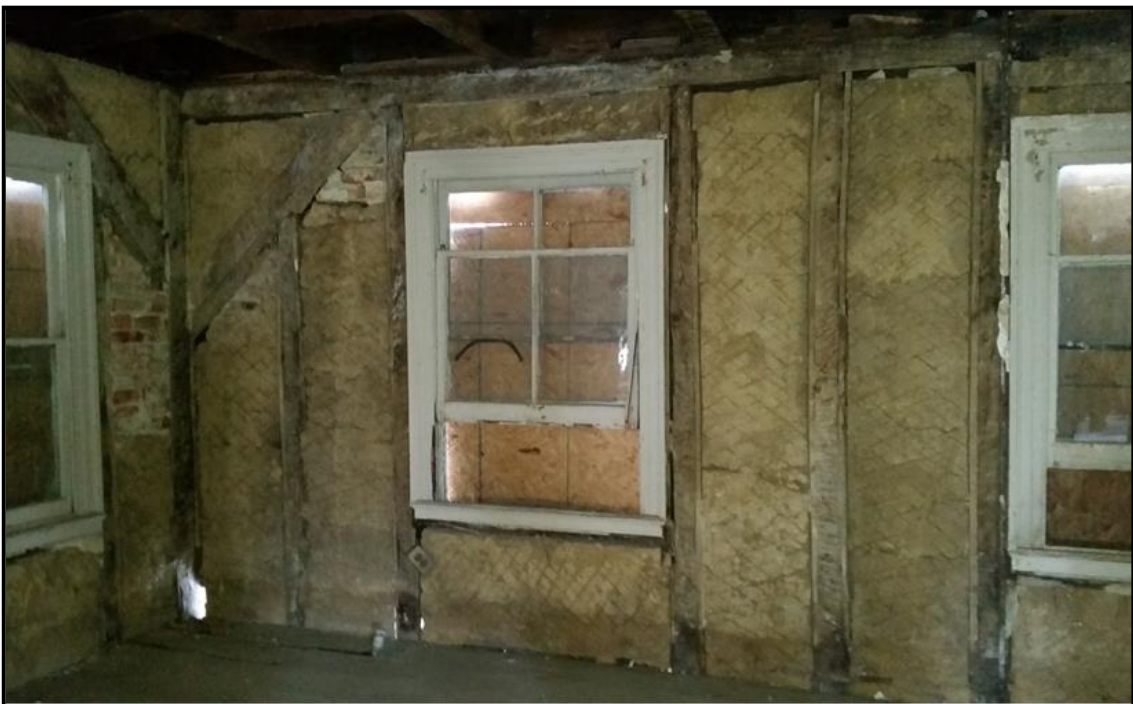
View south, showing the south wall and southeast corner of the main block of the house on the second floor. Note the timber framing, with clay noggin in the walls. The clay is scored to take a rough coat of plaster—now removed.

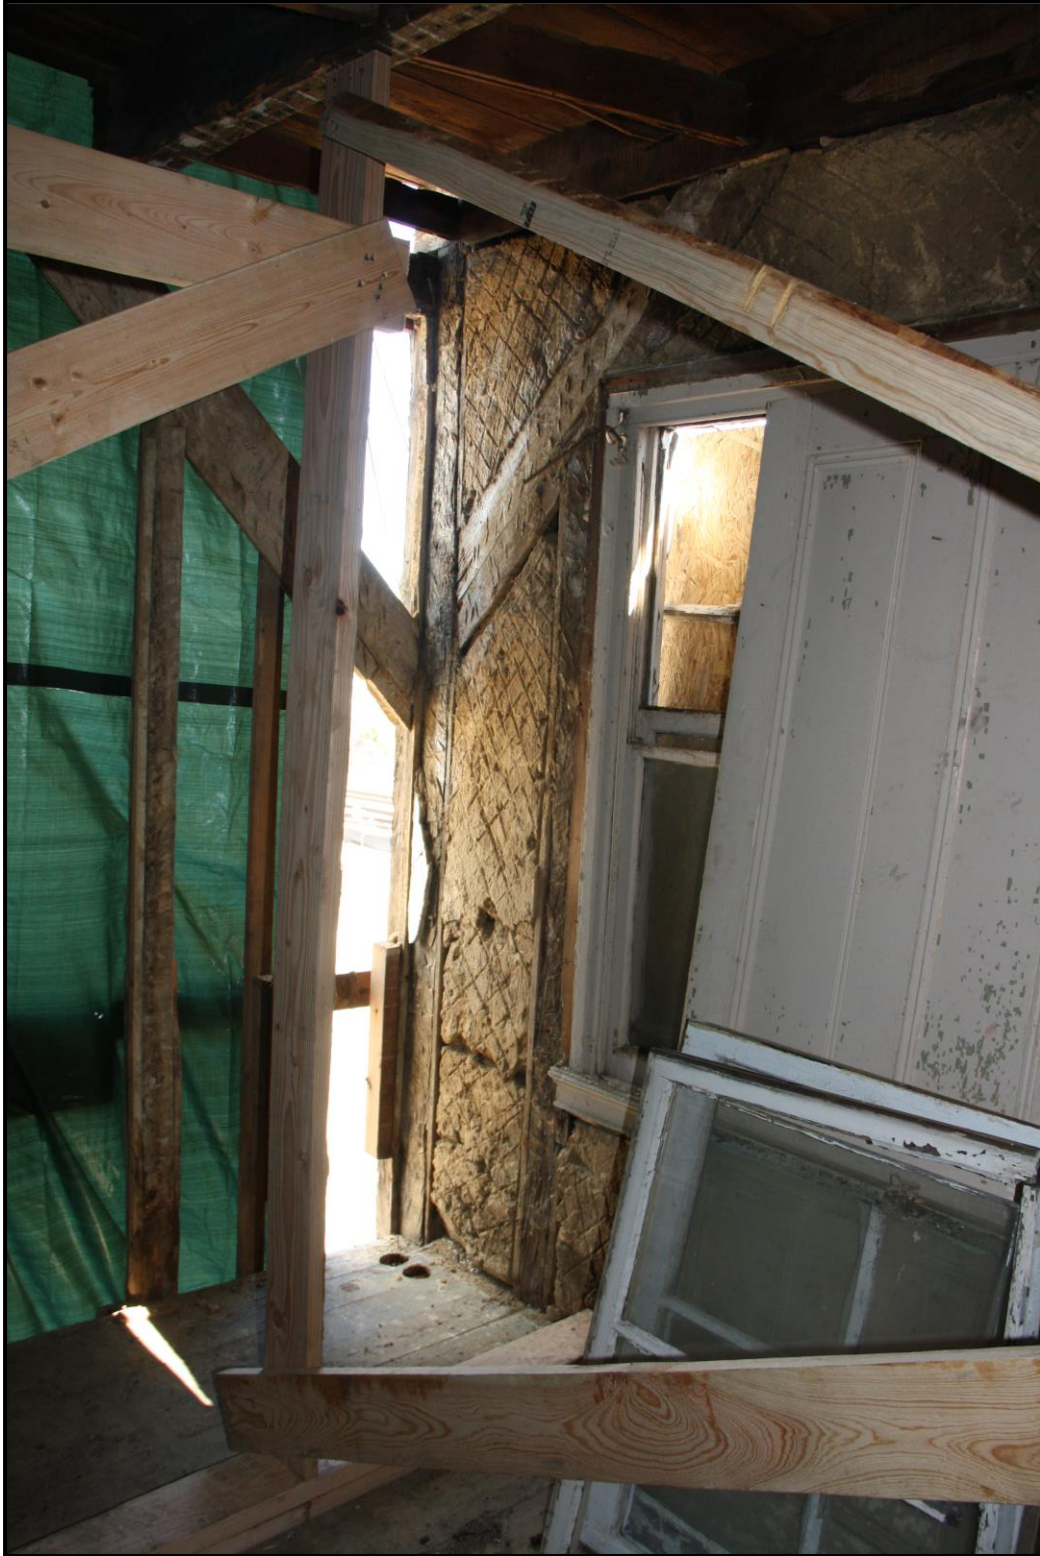
View Northeast inside the T. Thomas Fortune house showing clay wall nogging.

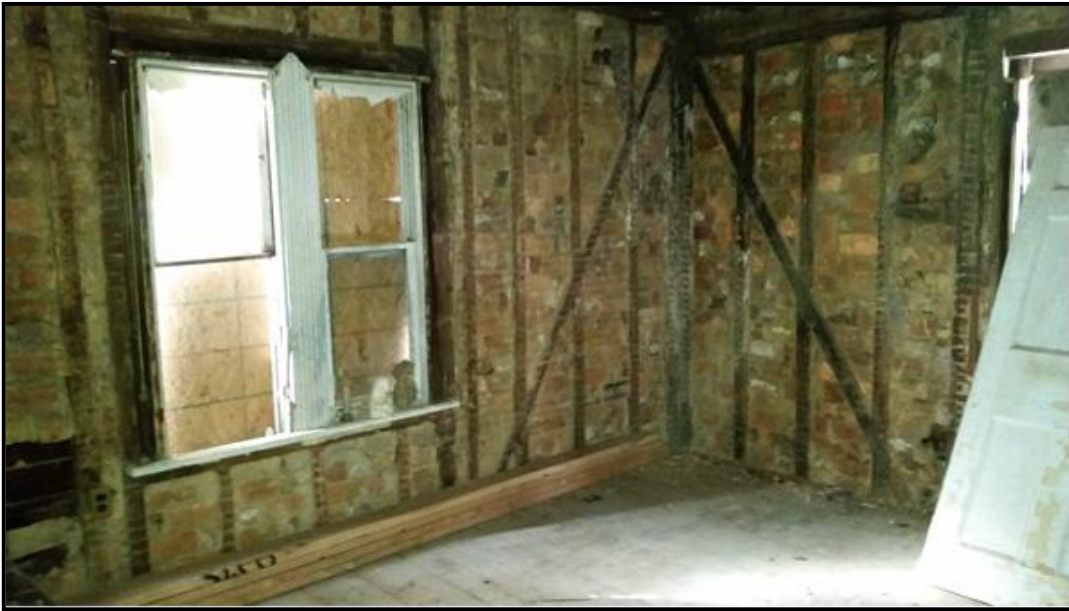
View south showing the northeast corner of the southern addition, with typically late 19th-century framing.

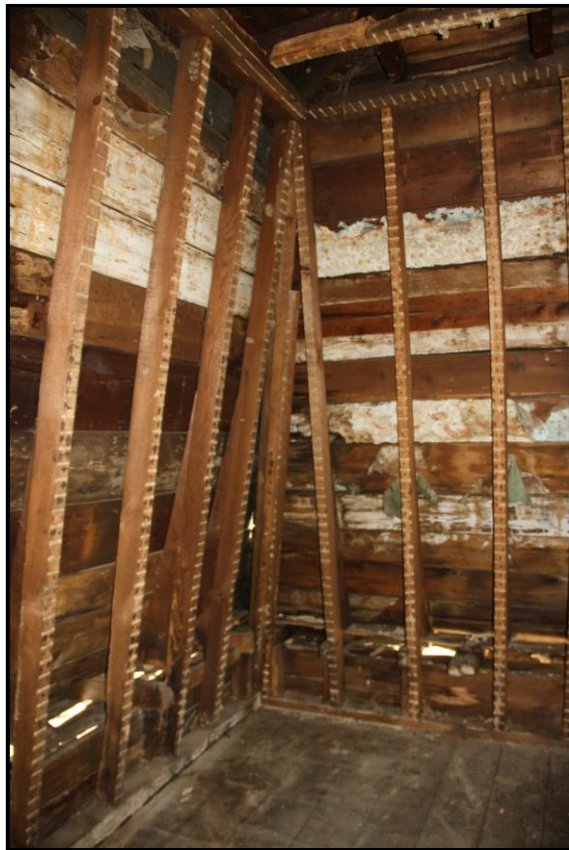
Victorian era framing for the mansard roof of the Fortune house.

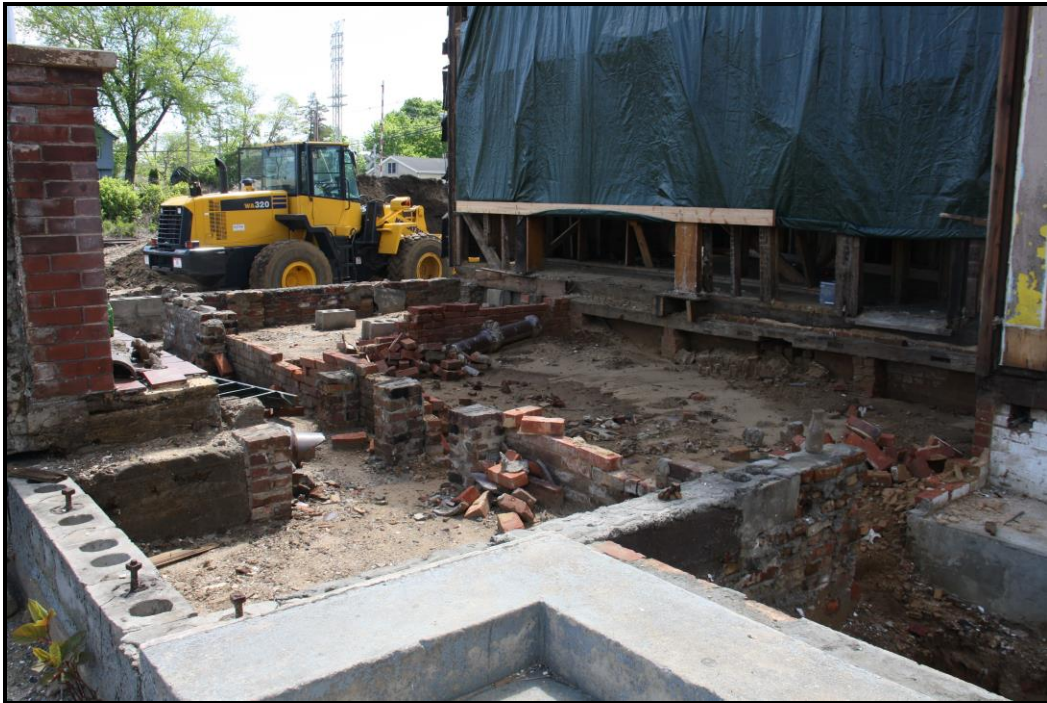
Rear of the Fortune house following the removal of 20th century additions. The brick foundation within the concrete block foundation may indicate the location of one or more earlier additions.

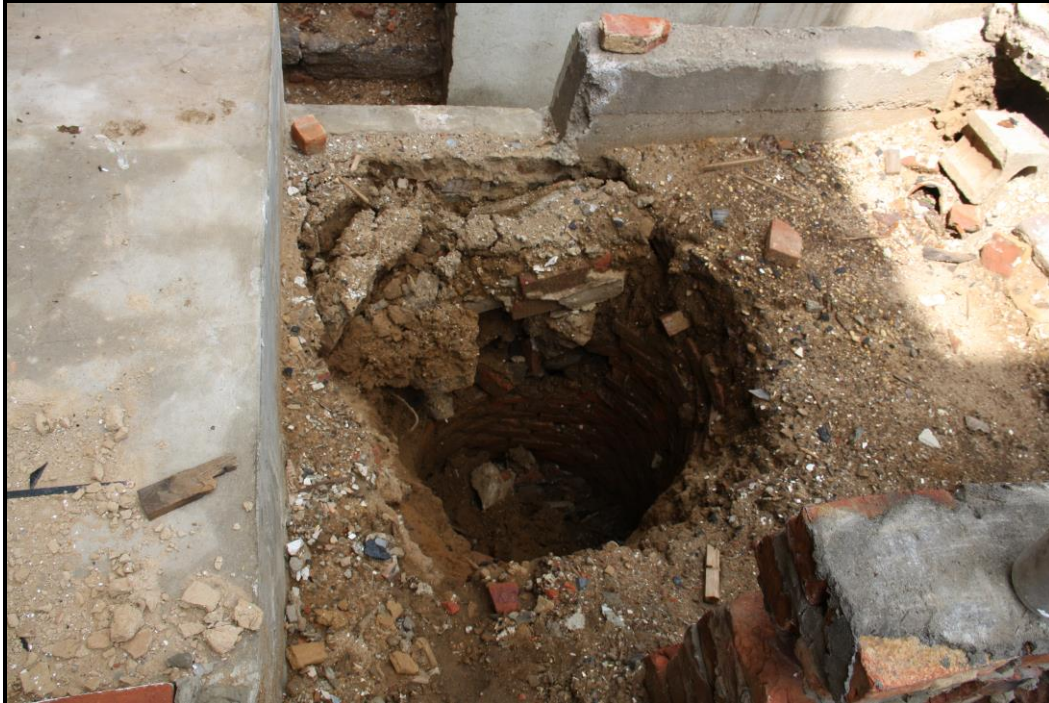
Well immediately behind the T. Thomas Fortune house.
